# TECHNICAL NOTES

## OSHA's Fire Service Features of Buildings: Commentary on an OSHA Publication Pertaining to Wood Trusses

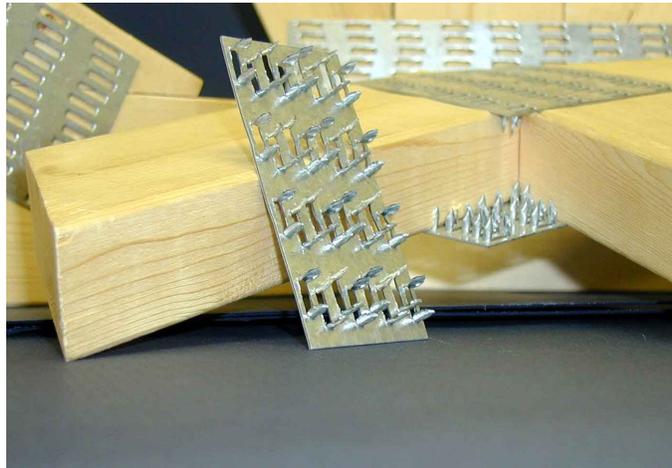
Photo 1

**Metal connector plate<sup>4</sup>:** Connector plate manufactured from ASTM A653/A653M, A591, A792/A792M, or A167 structural quality steel protected with zinc or zinc-aluminum alloy coatings or their stainless steel equivalent. The metal connector plate has integral teeth and shall be manufactured to various sizes (i.e., length and width) and thickness or gauges and shall be designed to laterally transmit loads in wood. Also known as truss plate, plate, metal plate, etc. (see Photo 1)

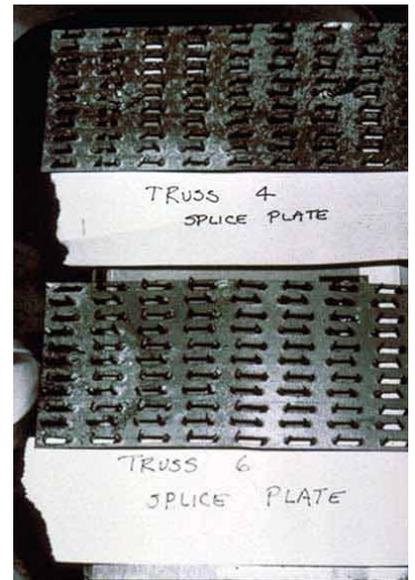
As an example, the connector plates in Photo 2 were exposed to an ASTM E119 test fire that burned for 60 minutes and reached 1700 degrees Fahrenheit. The plates show no visible signs of distress, and they look no different from normal plates other than the charred wood remaining on the teeth, and discoloration from having been exposed to extremely high temperatures.

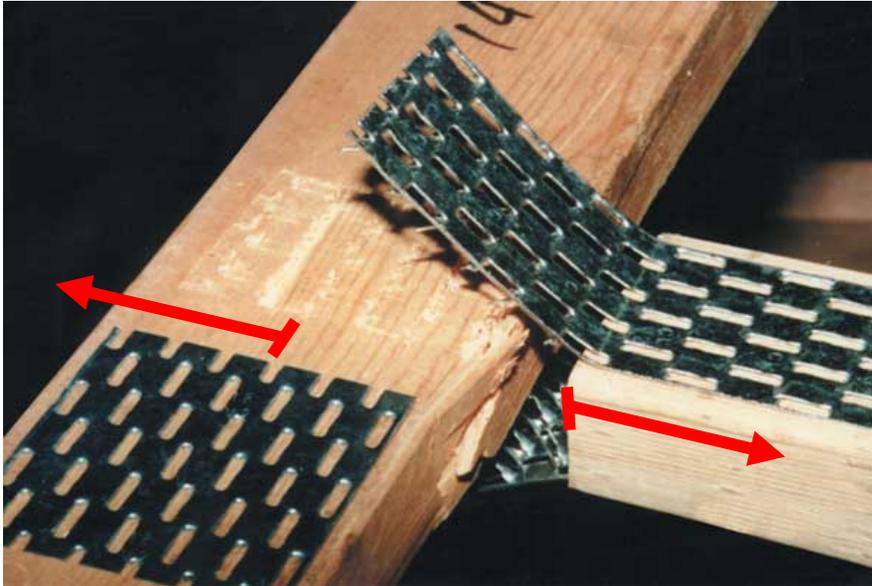
Photo 3

Truss joints typically fail as the fire degrades wood members they are connecting together the same way they fail under excessive loads – in withdrawal resistance failure mode. This failure mode is shown in Photo3 in which the two wood members were pulled apart with enough force to cause joint failure.

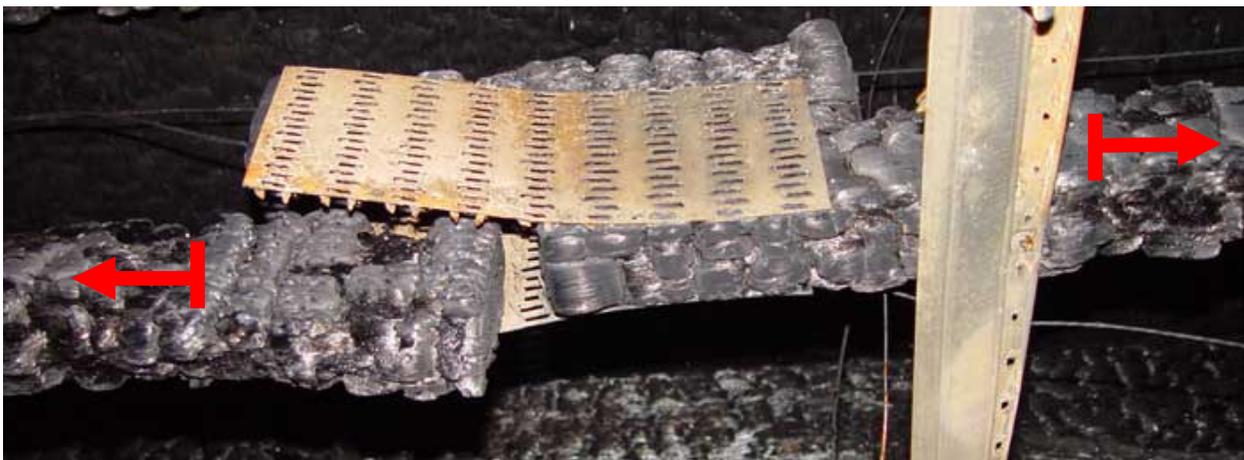
Photo 4

This failure mode can also be seen with this charred bottom chord splice joint in a truss (see Photo 4). The plate pulled out of the wood due to the forces exerted on it by the members pulling apart as shown. Note the characteristic curled shape taken by the connector plate in the withdrawal resistance failure mode.

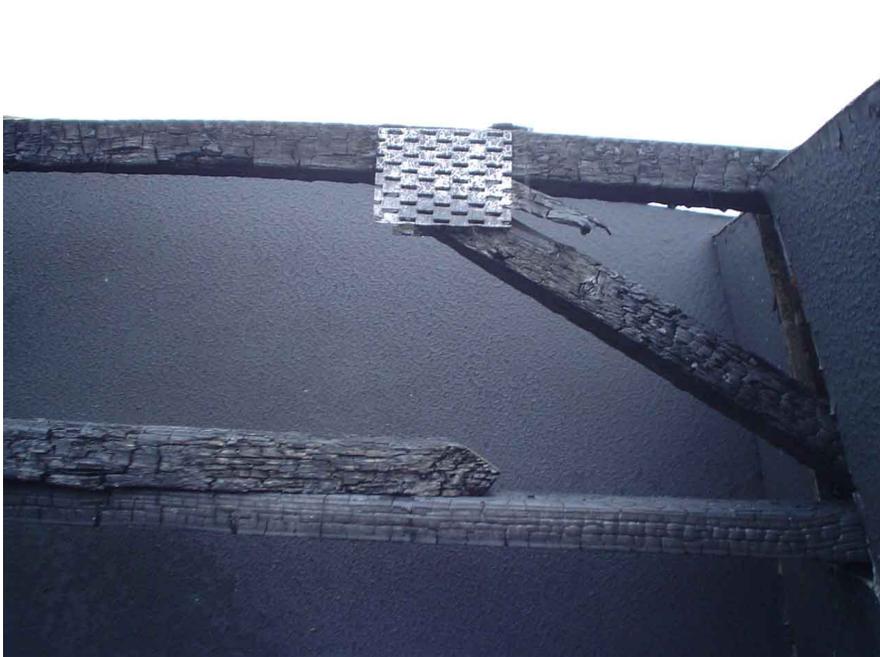
**Photo 5**

If charring occurs in fire but the withdrawal forces are not great enough, connector plates can stay connected even after significant charring, as you can see in Photo 5.

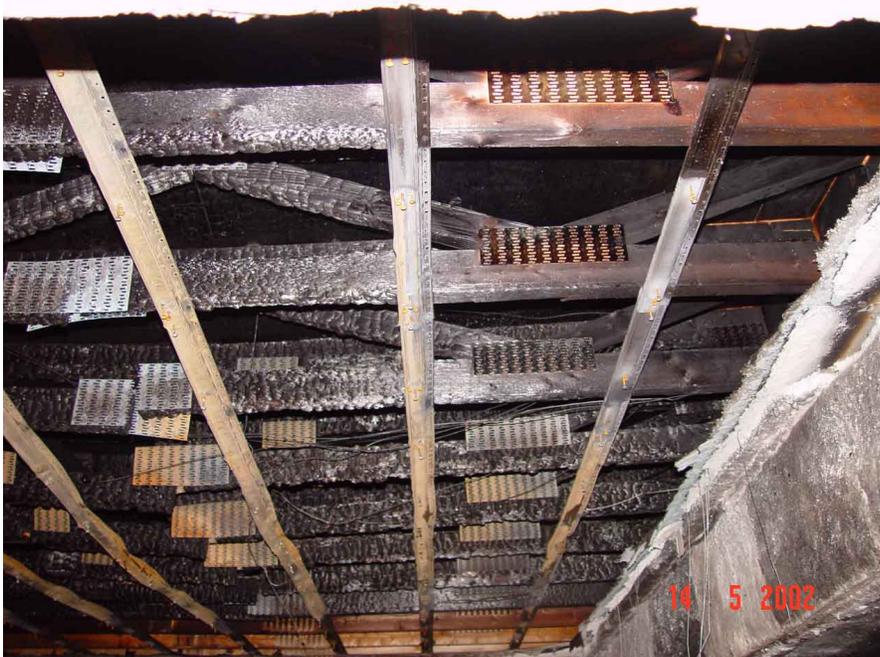
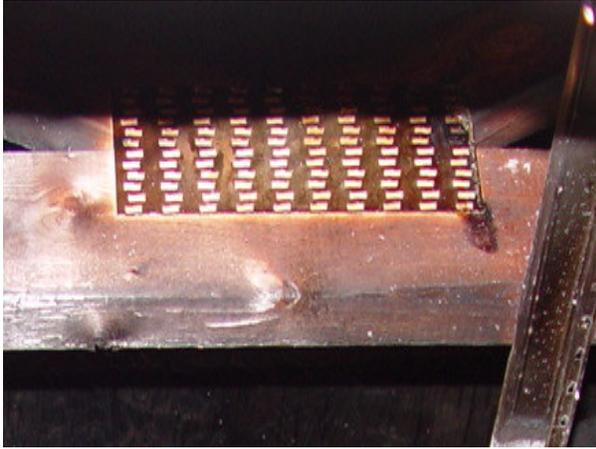
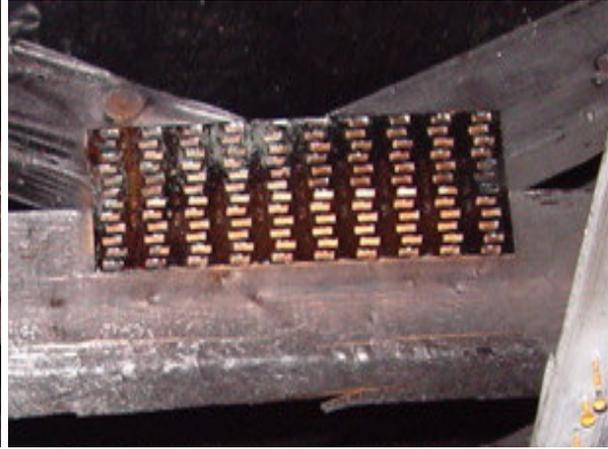
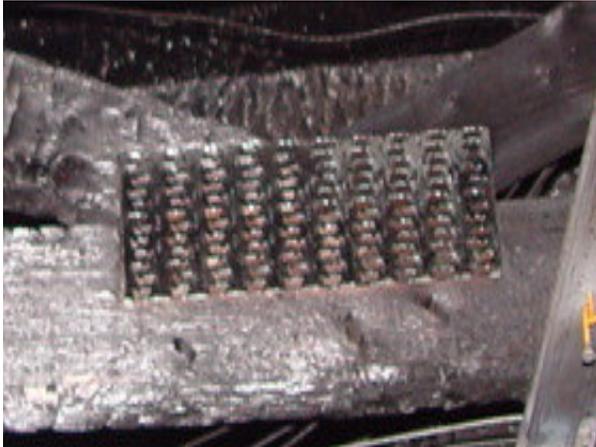
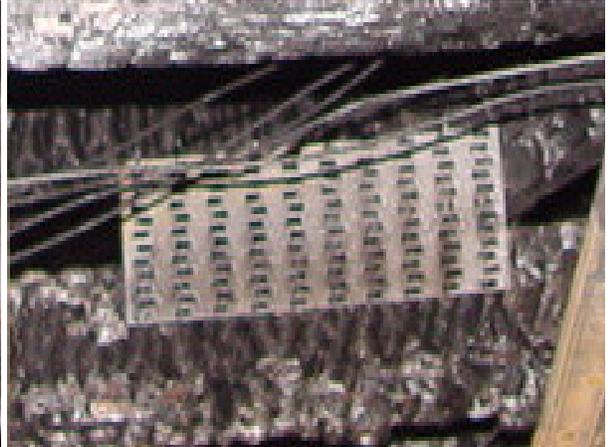
These concepts are described more fully in the Carbeck Education Program *Wood Truss Construction and Fire Performance*<sup>15</sup> and can be seen below in the following series of photographs of connector plates at successively greater fire exposures (see Photos 6 – 10). These photos come from a test fire where parts of the floor assembly happened to receive differing degrees of fire exposure, as evidenced by the increasing amounts of char seen on the joists toward the back of this assembly.

Another common misperception is that metal connector plates help promote failure in fire by accelerating char on the wood below them. As can be seen in the preceding photos, the truss plates do protect the wood for a period of time prior to becoming a heat conductor. This is due to the moisture in the lumber below the plate. According to Canadian fire researcher Leslie Richardson:

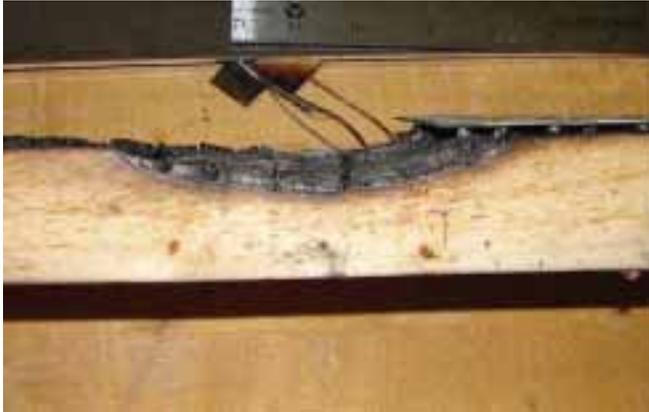
**Photo 11**  
*Courtesy NIST and Kelly Harman*<sup>18</sup>

This concept is also more fully described in the Carbeck Educational Program<sup>17</sup> entitled *Fire Performance of Metal Connector Plates* and can be seen in Photos 11 and 12:

<sup>18</sup> From a draft thesis entitled “A Study of Metal Truss Plate Connectors When Exposed to Fire” by Kelly Harman, E.I.T and James Lawson, 2005. This was based on research done at the National Institute of Standards and Technology in 2005.

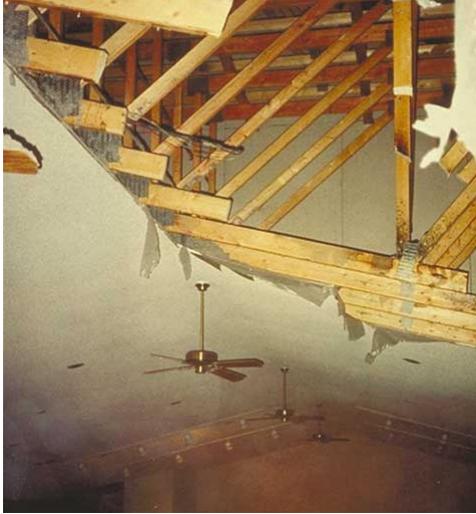
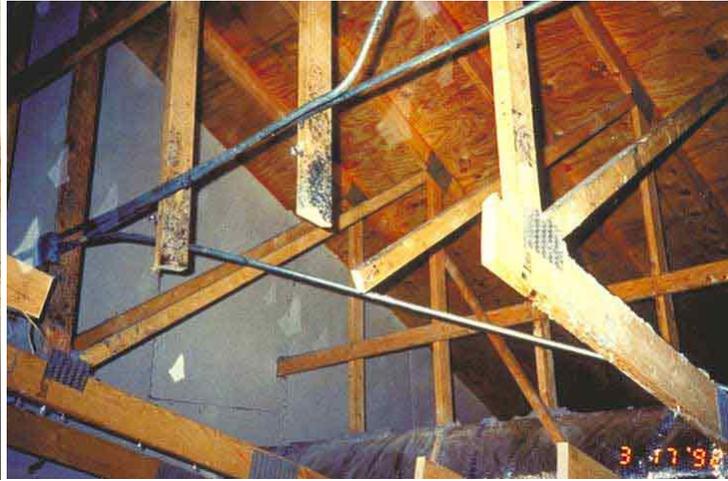
When a member or joint in a metal plate connected wood truss is broken, the truss loses much of its strength, but it retains some of its load carrying capacity. This is due to the moment carrying capacity of the metal plate connected joints, and the ability of the nearby members and joints of a truss to share loads.<sup>21</sup> This concept is also more fully described in the Carbeck Educational Program<sup>22</sup>, entitled *Wood Trusses after a Church Fire*, and can be seen in the Photos 13 and 14:

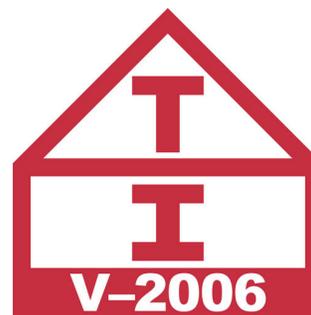
Where there is resistance to putting in place an easy to implement and use pre-fire planning system, *universal* building labeling may be an option to be considered. In this second choice, all construction types in all buildings need to be labeled. This would provide all the information that firefighters need to guide fireground decision making and not mislead them.<sup>38</sup> Photo 15 provides an example of a label in such a labeling system.
